National Transportation Safety Board Aviation Accident Final Report

Location:	Windsor Locks, Connecticut	Accident Number:	ERA20MA001
Date & Time:	October 2, 2019, 09:53 Local	Registration:	N93012
Aircraft:	Boeing B17	Aircraft Damage:	Destroyed
Defining Event:	Landing area undershoot	Injuries:	7 Fatal, 5 Serious, 2 Minor
Flight Conducted Under:	Part 91: General aviation - Other work use

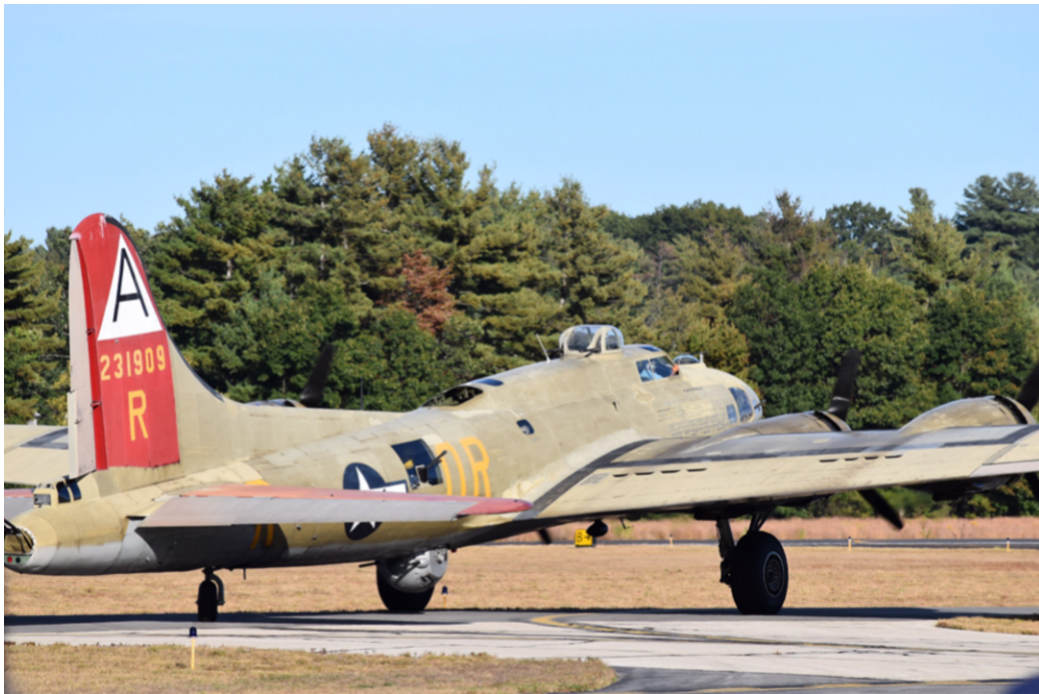
Figure 1. Accident airplane

The accident airplane, shown in figure 1, was a vintage, former US military bomber that was on a tour that allowed members of the public to purchase an excursion aboard the airplane for a living history flight experience (LHFE). After the passengers boarded the airplane, they were seated by the crew chief/flight engineer (referred to as the loadmaster). The 20- to 25-minute flight included a planned in-flight walking tour of the airplane.

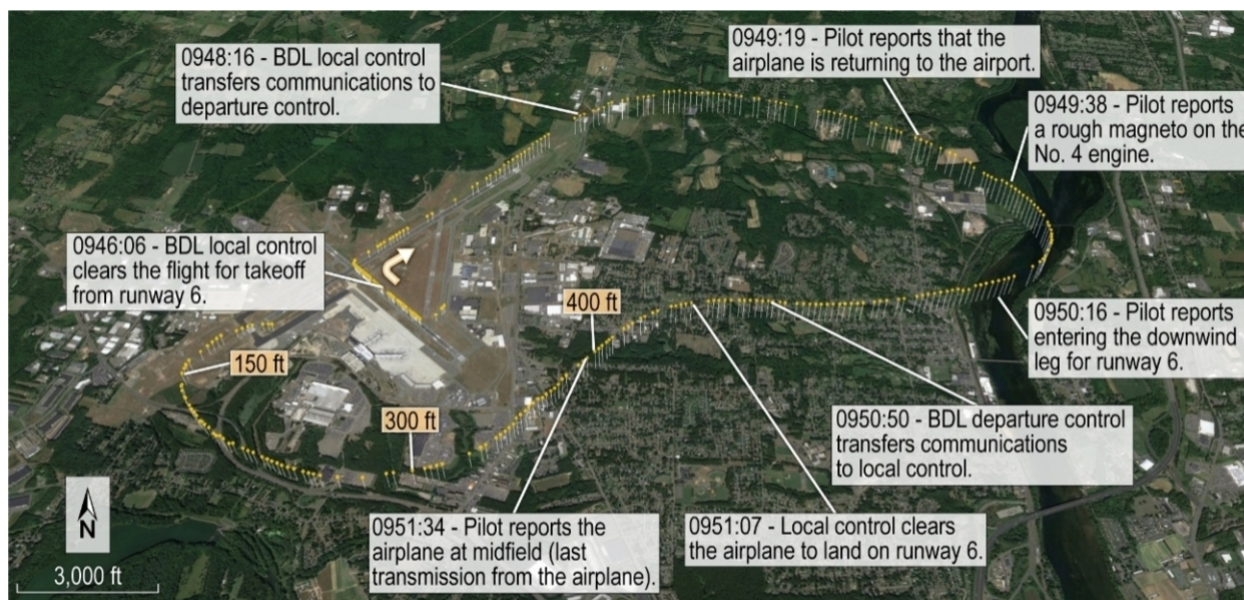
Figure 2. ADS-B-derived flightpath and select voice radio transmissions

The airplane was descending through an altitude of 300 ft as it turned onto the base leg of the traffic pattern for runway 6. The airplane then turned onto final approach at an altitude of 150 ft; at that time, the airplane was about 0.4 nautical mile from the runway threshold. Figure 2 depicts the airplane's ADS-B-derived flightpath overlaid onto aerial imagery of the airport and surrounding area along with relevant voice radio transmissions between air traffic control (ATC) and the airplane.

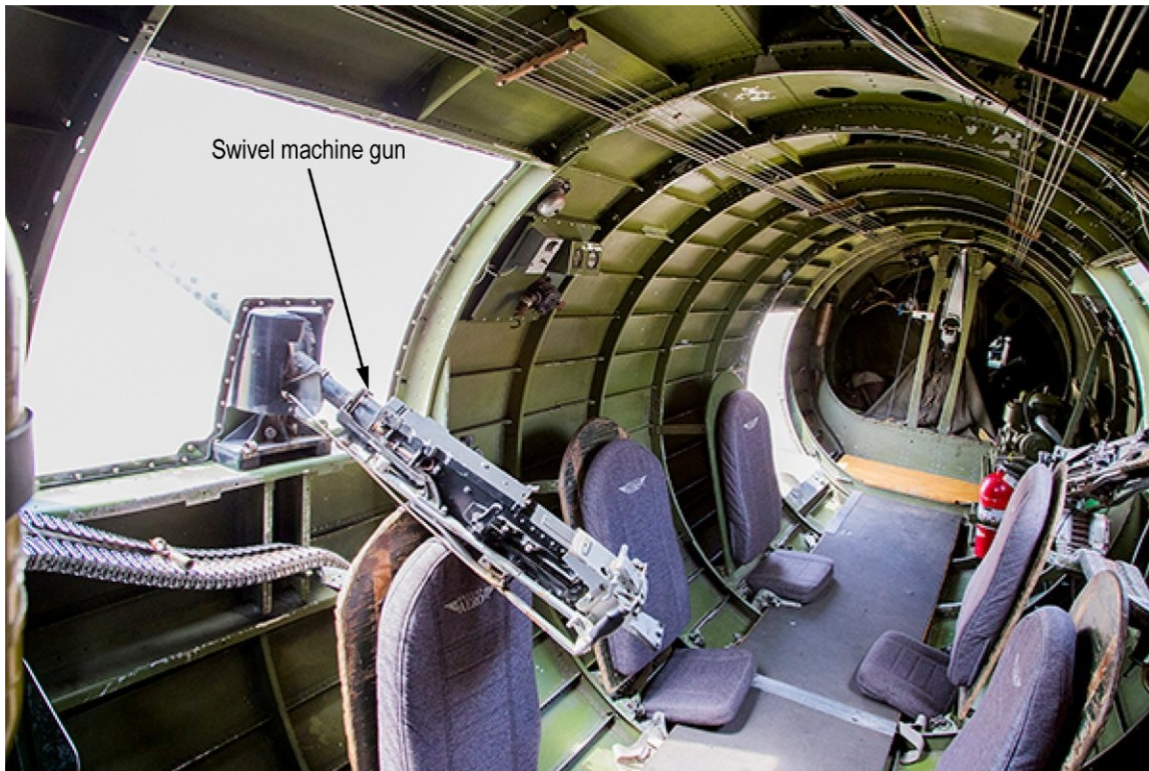
Figure 3. Accident airplane interior (forward looking aft)

The passenger seats that were not original equipment were installed in the airplane according to an engineering document that conformed with the structural requirements of *Civil Aviation Regulation 4b*. Some of the seats consisted of a 5/8-inch-thick plywood seatback attached to the airframe with aluminum angles and brackets, as shown in figure 3. The other seats were secured directly to the structure on an airplane sidewall or bulkhead. All of the passenger seats included a seatback cushion secured with hook and loop fasteners and a seat bottom cushion secured to a floor panel. The passenger seats were equipped with a two-point military/aerobatic-style lap belt affixed to either the seat or structural areas on or near the floor.
